Services to the Insurance Industry

kerosene Contamination Under a Residential property. Somerset

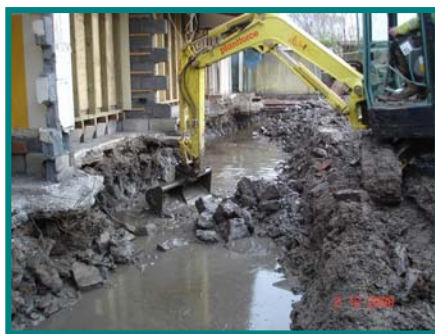
Sorting / segregation of material within the excavation. Rear of bungalow removed.

The rear elevation of the bungalow and the concrete raft spanning the backfilled rhine were removed to provide access to remove the heavily contaminated water, silt, clay, boulders and building rubble in the backfilled rhine. Large boulders and bricks were carefully sorted and segregated within the excavation and disposed of as inert waste in roll/on off skips. An oil/water separator system was set-up in the front garden; oil and oily water from the excavation were removed by an automated vacuum pumping system (Ecovac) and conventional electric submersible pumps. The treated water was pumped through an activated carbon filter and discharged to surface water under a consent from the Environment Agency. The system was used throughout the work to remove free product and de-water the excavations.

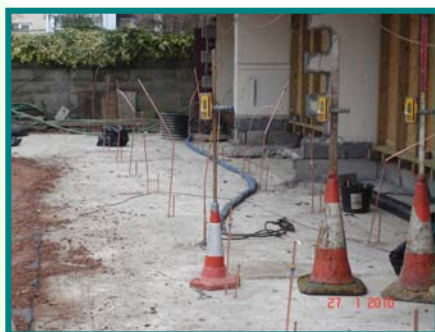
Injection of Uretek low density resin into void space under ground bearing slab

The design of the reinstated ground bearing slab had to be carefully considered due to the very soft ground and the need to avoid differential settlement with the existing building. A scheme was devised whereby the rhine was partly backfilled with a specialist lightweight aggregate which was in turn overlaid with a conventional granular fill. A reinforced concrete raft was formed over the backfilled rhine and the void space subsequently injected with a specialist geotechnical resin (Uretek) via 30 pre-drilled pressure injection points.

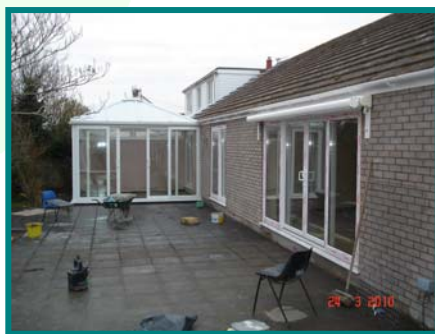
Rear of bungalow re-built on completion
