Remediation

Air Sparging – Gloucestershire

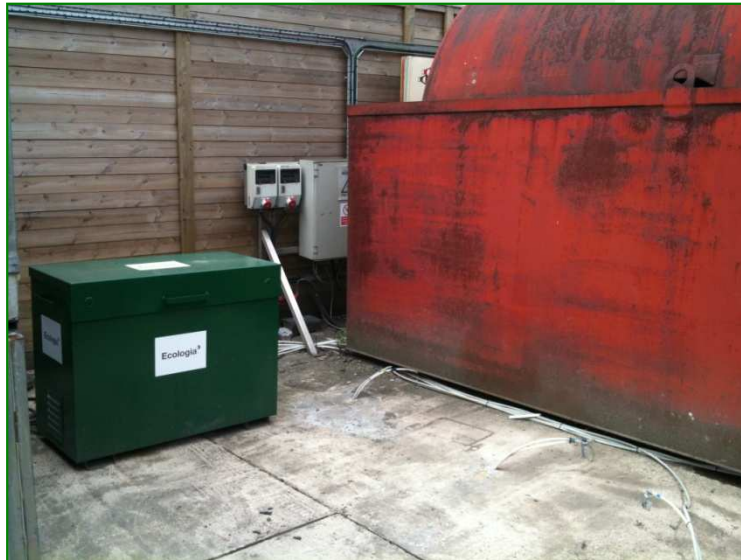
Sparging system during operation

A total of 12 sparging wells were installed into the remediation area. The wells were drilled to 4 metres below the water table using Ecologia's own drilling equipment. The air feed lines were cut into the concrete hardstanding, allowing normal business to continue unhindered.

The sparging equipment was designed and manufactured by Ecologia in Sittingbourne. The equipment was telemetrically controlled and allowed automated monitoring of the dissolved oxygen concentration in the groundwater. The inclusion of genuine two way telemetry allowed Ecologia to greatly reduce the quantity of site visits required.

The sparging system created oxidic conditions and increased the Redox potential to over 50 mV and the dissolved oxygen content to 4ppm within three weeks. The oxidic conditions were maintained over 12 months until the remediation target was achieved under a fixed price contract to attain the remediation targets.
