Remediation

Commercial redevelopment of a former service station – Whitstable, Kent.

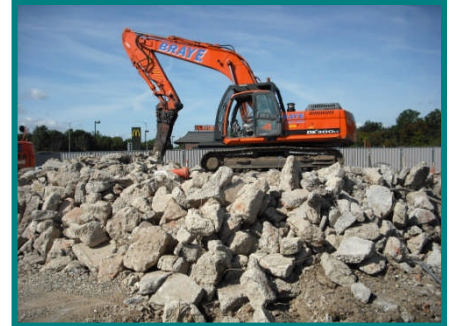
Breaking up the concrete hard standing across site.

Ecologia's first task on site comprised breaking out and removal of the concrete hard standing cover allowing access to the underlying soils. Following removal of the overlying concrete, petroleum and diesel contamination was encountered in the soils surrounding the UST area. A bunded area was created on site and hydrocarbon impacted soils were excavated and transferred to this area for stockpiling and treatment with an oxygen release compound. The USTs were removed from site for suitable recycling.

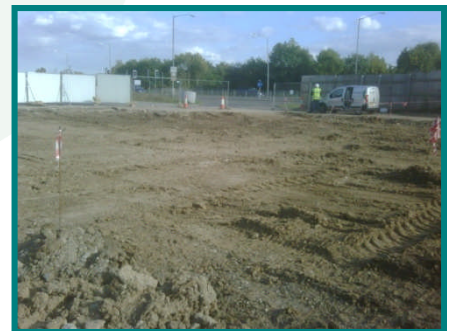
Former Chestfield Service Station upon completion of remedial works

Four boreholes were also drilled and installed as monitoring wells to facilitate groundwater monitoring to assess potential offsite migration of contaminants. No contaminants were encountered in groundwater samples. A validation remediation report was compiled by Ecologia following completion of the work on site, which included details of the materials stockpiles register and all laboratory soil analysis. The reports were submitted to the Local Authority and Environment Agency for their review and comment to complete the project. Favourable replies were received by both regulatory authorities, allowing the Client to progress with the second build phase of the works. The Project was brought in on time by Ecologia within the terms of our fixed price contract.
