Site Investigation | Risk Assessment

Investigation of Brownfield site to meet planning conditions pertaining to residential development at an East London former Transport Depot.

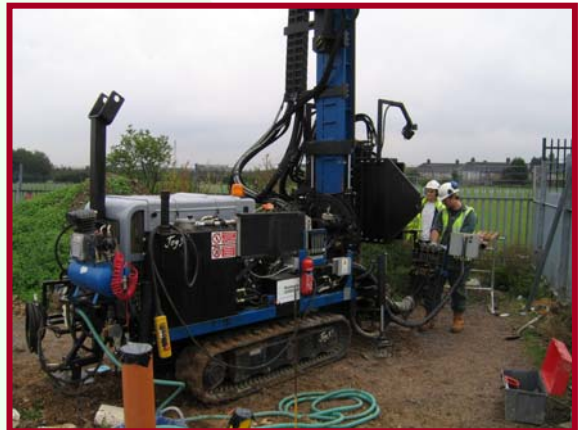
Nearing completion, validation testing was completed by means of small shallow trial pits in each garden area to confirm the site met the current guidance on suitability for residential use.
