Remediation

Air Sparging – West London

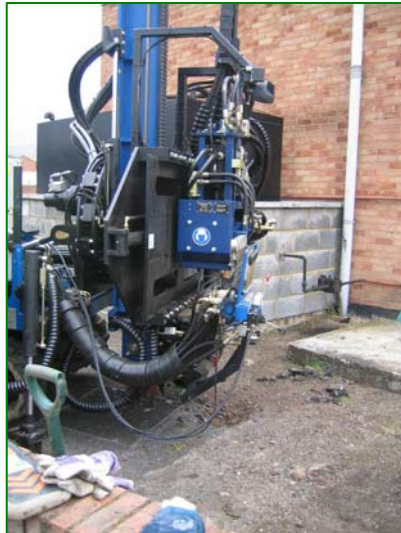
Installation of the Sparging wells

A total of 12 sparging wells were installed into the remediation area which covered approximately 800 sq metres. The wells were drilled to 4 metres below the water table using Ecologia's own drilling equipment. The air feed lines were cut into the concrete hardstanding, allowing normal business to continue unhindered.

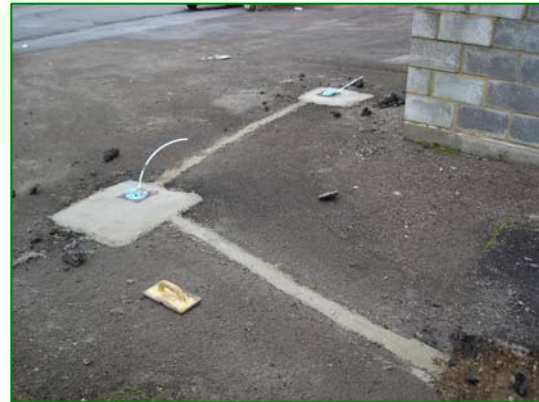
Sparging wells during installation works
